Chapter 10

Operating experience feedback from French research reactors

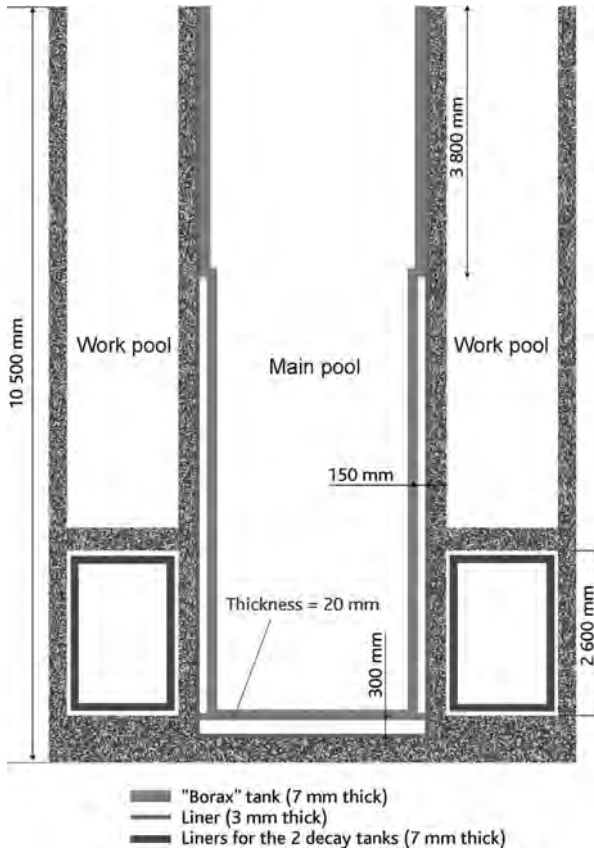
The first water leak from the main pool was detected in 1965 from the records of the makeup water added to compensate for the evaporation of water from the pool. The leak stopped in 1968 and reappeared in 1969. In 1970, a stream of bubbles was observed in the pool water, which made it possible to detect a crack between the ceramic tiles at the bottom of this pool (separated by araldite seals), near the foot of the “stool” supporting the reactor core. Leaktightness was restored by installing a stainless steel plate on the tiled floor, with a synthetic foam seal. However, the leak reappeared in 1971 due to the degradation of the seal caused by radiation. The leak was only sealed durably in 1972, with the installation of a flat, natural rubber seal held against the bottom of the pool with lead.

However, in November 1986, an increase of approximately 1 m³ in the makeup water added to the pool to compensate for evaporation was observed once again. After checking the leaktightness of various reactor systems, the reactor was shut down at the start of December 1986 for a detailed inspection of the main pool, suspected to be the source of the water leak. This inspection required the fuel elements to be unloaded,

Figure 10.1. Pools and decay tanks at the SILOE reactor: tanks and liners installed in 1987-1988.
© Georges Goué/IRSN.

This event threatened the future of SILOE²⁶⁰, given the high cost of the work needed to return the reactor to good condition. However, the CEA decided to undertake this work so it could continue operating and performing experiments at this reactor, and scheduled the permanent shutdown of the MELUSINE reactor, which had been commissioned in 1958 and whose experiments could be transferred to the SILOE facility. The corresponding modifications, authorized by the SCSIN in summer 1987, were considerable. A stainless steel liner was installed in the main pool, welded to backing strips also made from stainless steel and fastened to the pool walls. A gap was left around the edge of the pool, equipped with a system to detect leaks and recover any leaks from the liner. Regarding the capacity of the pool to withstand a BORAX-type accident, while the leaktightness of the neutron channel penetrations seemed assured, the technical inspection highlighted the weakness of one of the pool walls. This led the operator to install a tank – known as a BORAX tank – able to deform and thereby absorb some of the energy that would be released in the event of such an accident²⁶¹, in order to protect the liner and pool walls. With the same aim in mind, a stainless steel plate 20 mm thick, positioned on shock absorbers known as “resilient pads”, was installed on the basemat, under the BORAX tank, in order to guarantee the mechanical resistance of the pool basemat to the pressure that would result from a BORAX-type accident. Liners were also installed in the decay tanks, with leak detection and water recovery systems. These various liners and tanks are shown in figure 10.1.

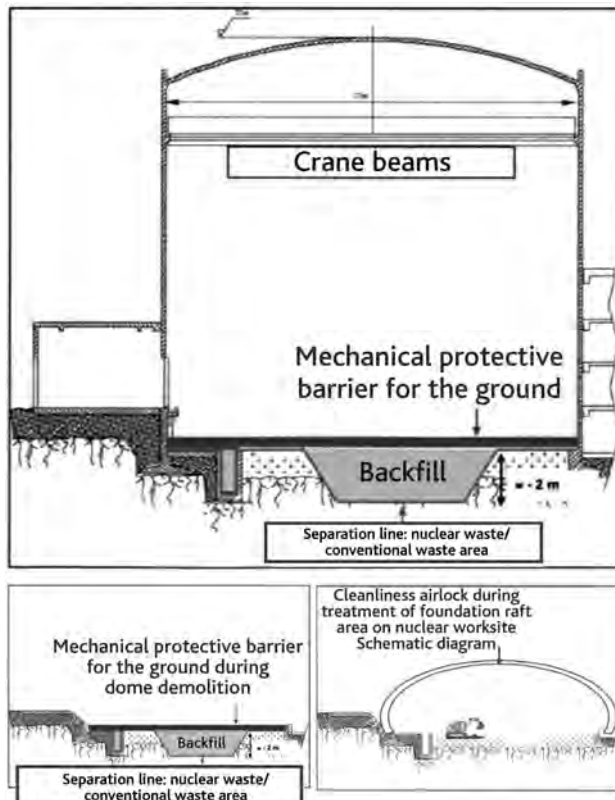
In 2011, the CEA informed ASN of the presence of contamination in the thickness of the basemat around the prestressing cables and in part of the ground located under the basemat (locally, the specific activity reached 25 Bq/g). This meant that the cleanup of the SILOE foundation raft had not, at this stage, achieved the cleanliness targets initially set. For its part, ASN did not favor managing this situation through the implementation of a “public service easement²⁶³”. Furthermore, full cleanup required in-depth treatment that could affect the mechanical strength of the reactor building. This is why the CEA ultimately decided to fully demolish the dome and cylindrical walls of the reactor building, as well as the auxiliary buildings, before completely removing the basemat and the contaminated soil. The corresponding work is illustrated in figure 10.2.

Figure 10.2. Some of the dismantling stages of the SILOE reactor (2010s). © All rights reserved.

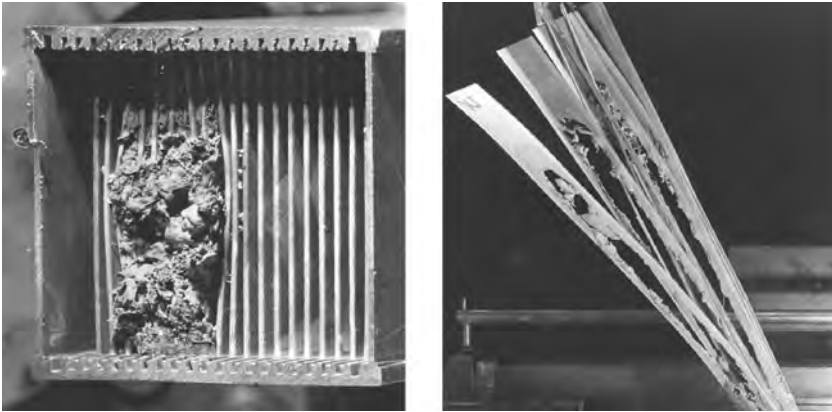
On November 7, 1967, six fuel plates in a control element²⁶⁸ partially melted in the SILOE reactor during a power increase to 42.3 MW performed as part of preparatory tests for taking nominal reactor operation up to 30 MW²⁶⁹. These tests, authorized by the CSIA²⁷⁰, notably aimed to determine the power margins available in relation to the “flow redistribution” phenomenon in fuel elements (described in detail below). At 42.3 MW, a sudden drop in power was observed of approximately 7 MW in one second, followed by a slower drop until it stabilized, 20 seconds later, at 20 MW. The reactor was shut down manually 26 seconds later by dropping two safety absorbers. A rapid increase in γ radiation dose rates was then observed (in an immersed measurement chamber, up to 1,000 rad/h, and in another measurement chamber, located above the pool water, up to a value of 220 rad/h), which led to the evacuation of the reactor building and auxiliary buildings, as well as the use of the iodine filters on the emergency ventilation system.

This event caused 187 g of uranium and aluminum alloy (enriched to 93% uranium-235) to melt, corresponding to a mass of 36.8 g of uranium-235, 18 g of which was released into the reactor coolant system. The remainder was found in the form of magma at the bottom of the control element (figure 10.3).

The cause of melting was not clearly established. In this respect, the results of the investigations carried out by the operator following this event, which notably involved measuring the temperature of the same type of control element cladding positioned in the location where the melted fuel plates were found, at powers of between 0 and

Figure 10.3. Two views of the melted plates in the control element at the SILOE reactor. © ILL.

39 MW, seem to rule out the flow redistribution hypothesis²⁷¹; indeed, the extrapolation of these measurements to 42.3 MW gave, for the melted plates, a temperature at the hot point of the cladding below that corresponding to local boiling (116°C as opposed to 128°C). In addition, the hottest plate of the control element did not melt.

- the painted sheet metal structures overhanging the core, used for routing the cables and hoses of experimental devices, were replaced with stainless steel structures;
- a second emergency exhaust system was installed at the facility to improve the reliability of this safety-related system;
- systems were installed to allow the air above the pool and the water from the pool to be sampled from outside the reactor building;
- controls for the pool water purification system were installed in the control room.

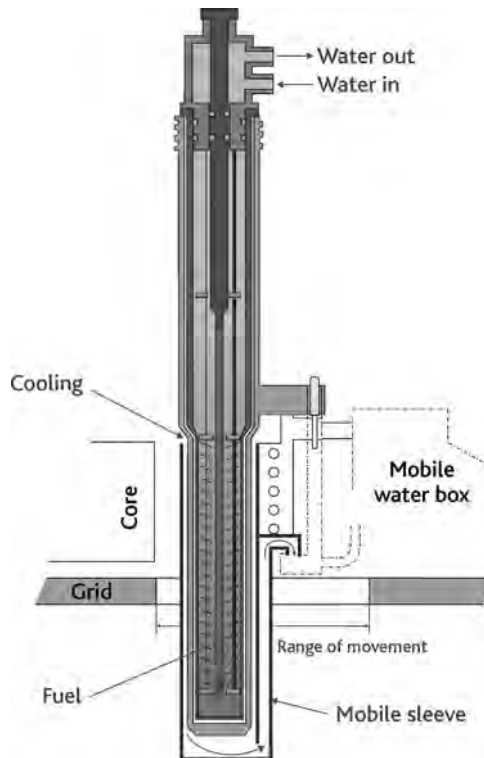
The explosion of the AQUILON experimental irradiation device occurred at the SILOE reactor on April 10, 1979. This device – similar to the “boilers”²⁷² used for tests on light water reactor fuel – was positioned at the edge of the core and contained an irradiated uranium oxide fuel rod (UO_2 ; uranium enriched to 4.7% isotope 235). The explosion of the device caused uranium oxide and fission products to be released into the reactor pool, and noble gases and iodine to be released into the reactor building and environment.

In the device (figure 10.4), the water was practically static²⁷³; its pressure was adjusted depending on the heat released by the fuel rod in such a way as to achieve

Figure 10.4. Section view of AQUILON device © Georges Goué/IRSN.

- the device sleeve showed signs of heating and had two holes;
- the test fuel rod was partially melted;
- the upper part of the external plate of a fuel element located near the device "water box" was deformed, without cladding failure.

The cause of the event was determined: the sleeve had shifted when the AQUILON device was being removed, which had:

All the fuel elements in the SILOE reactor core were checked using a mobile cladding failure detection device. The six elements closest to the AQUILON device were replaced. Authorization to restart the reactor was granted by the SCSIN after a shutdown lasting ten days, largely spent purifying the pool water. However, the use of “boiler”-type devices was suspended, notably to assess the status of these devices in relation to pressure equipment regulations.

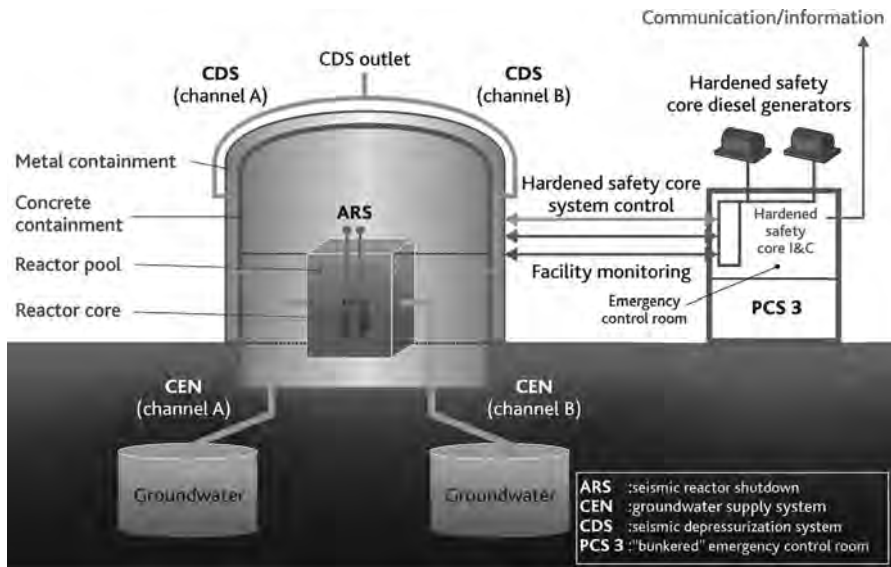
Figure 10.8. Schematic diagram of additional measures installed at RHF after the Fukushima Daiichi accident. © Georges Goué/IRSN.

- a new emergency control room (PCS²⁹⁸ 3 building);
- specific equipment (in PCS 3) to monitor some key parameters of the state of the facility (the core neutron flux, with two new neutron detectors attached to the reactor block in the light water pool; the configuration of the natural convection valves; the water levels in the reactor block and pool; and the pressure in the reactor hall and in the annulus between the two containment walls), with the values also being automatically sent to IRSN²⁹⁹ in the event of an accident.

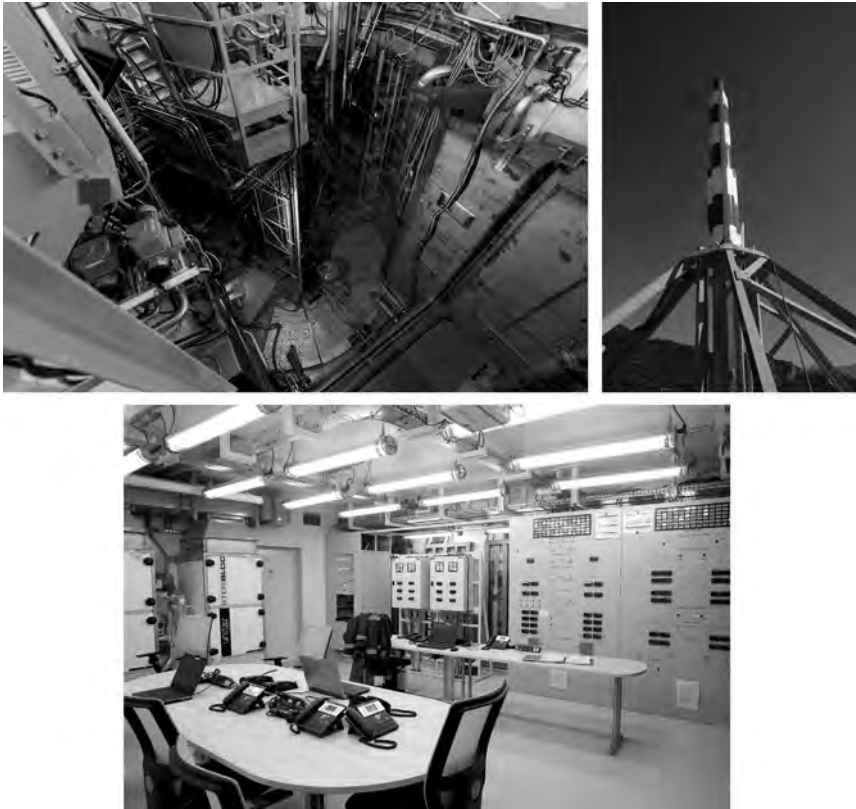
Figure 10.9. Three measures selected for the RHF at Grenoble after the Fukushima Daiichi accident, all designed and sized for extreme earthquakes and flooding: on the top left, the pool inlet elbow of the groundwater supply system. © IRSN; on the top right, the seismic depressurization system stack positioned on the dome of the metal containment. © ILL; at the bottom, the PCS 3 emergency control room. © Jean-Marie Huron/Signatures/IRSN.

loads, by setting the trigger threshold to 0.01 g ³⁰². It was then completely renovated to make it independent from the other reactor protection systems, and it was qualified for the “hardened safety core design-basis earthquake”. This provision ensures that the safety rods drop – even in the event of an earthquake without a weak movement phase (compressional waves known as P-waves) before the strong movement phase (shear waves known as S-waves).
