Accidents at the WIPP in February 2014

Summary of the actions carried out

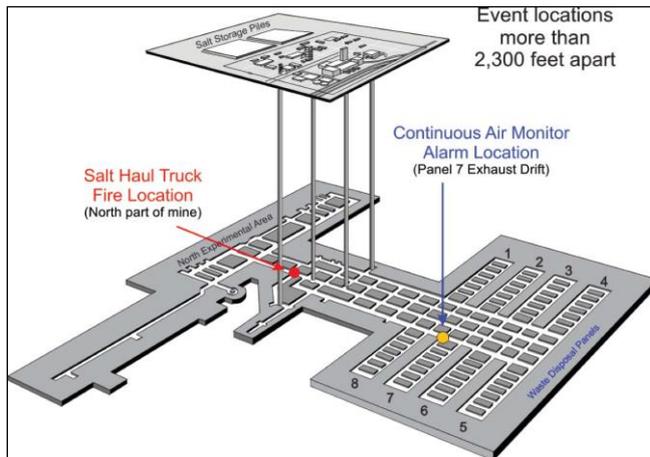
On February 5, 2014, a truck used to remove excavated salt caught fire in the northern part of the WIPP underground facility, near the salt handling shaft. The waste disposal panels are located several hundred meters from the site of the fire (see Figure 1); no waste packages were in the vicinity of the fire. The entire staff was evacuated from the underground facility. Six employees were transferred to the hospital due to possible smoke inhalation. The AIB attributed the causes of the accident and the events leading up to it [2] to multiple instances of negligence on the part of the DOE and its contractors, in particular concerning the maintenance of the salt haul truck, the inadequacy of the fire emergency procedures, the lack of fire extinguishing equipment of the underground facility and the training of personnel. The recommendations of the

Figure 1: WIPP overview. In red: fire location (north experimental area). In yellow: location of the CAM which triggered on February, 14 2014
<http://www.wipp.energy.gov/special.htm>

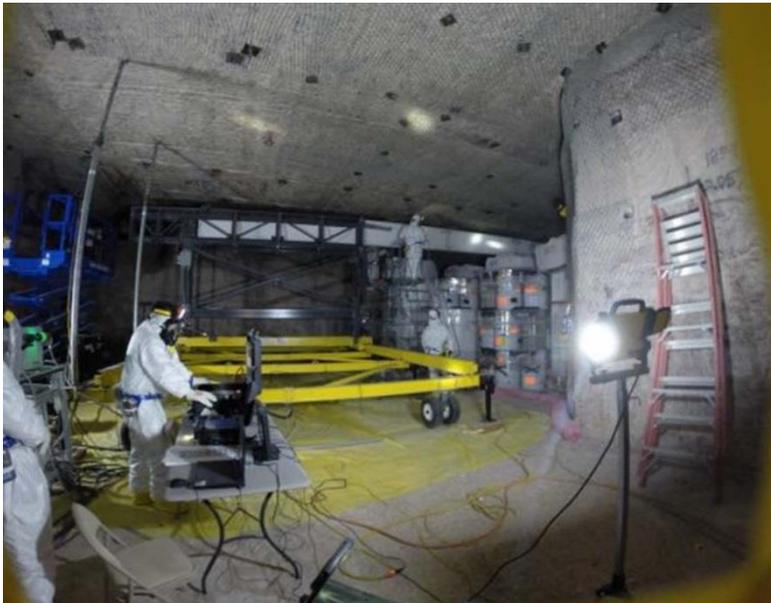
Robots and then successive expeditions of DOE intervention teams, outfitted with devices protecting against the inhalation of radioactive particles (see Figure 2), were sent into the underground facility beginning on April 2nd, 2014 in order to progressively approach the assumed source of contamination while, at the same time, providing for the essential maintenance of the facility (replacing the bolts to ensure the mechanical stability of the corridors, for example) [3]. During one of these expeditions in May 2014, a damaged waste drum (see Figure 3) was identified in Room 7 of Panel 7 and several samples of materials were taken between May and August 2014. Photographs have shown that certain materials had melted, which attests that a high temperature (on the order of hundreds of degrees around the offending drum and up to $1\,000 \text{ }^\circ\text{C}$ on contact) was reached in this room [7].

Figure 2: DOE personnel in the underground part of the facility in March 2015
<http://www.wipp.energy.gov/wipprecovery/townhallmeeting.html>

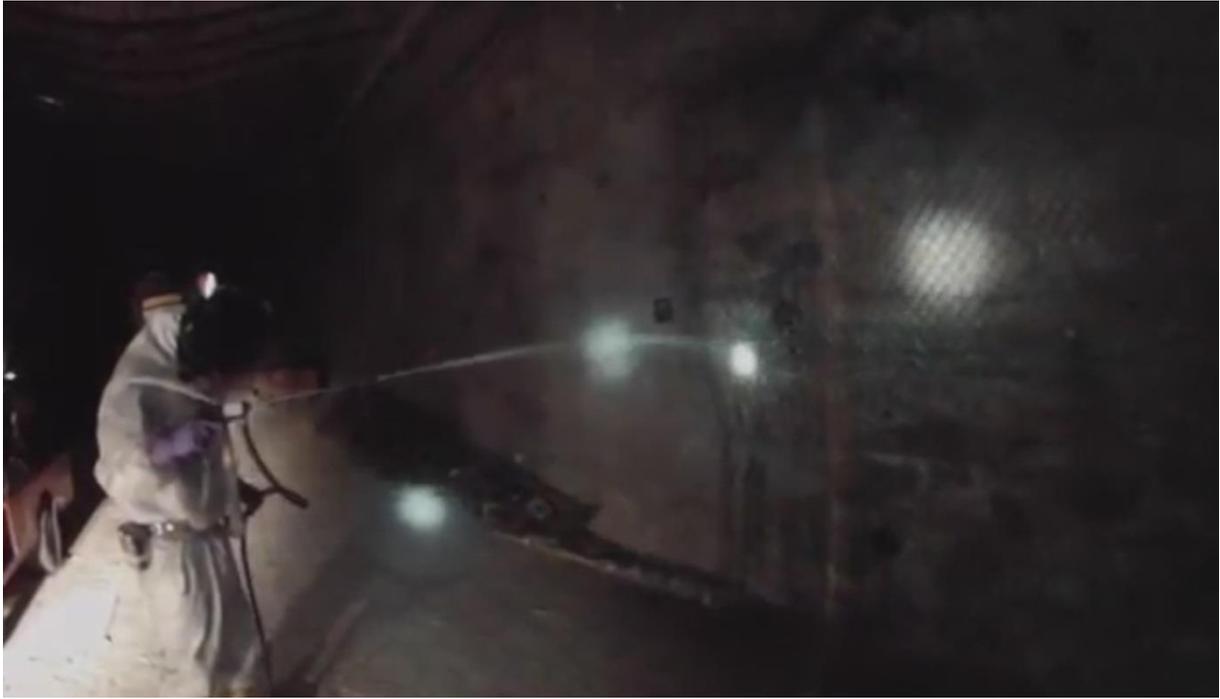
Figure 5: water sprayed on the ribs of the facility, picture taken from a video [http://www.wipp.energy.gov/Video/Mitigating_Contamination.mp4]

In the course of expeditions in the underground facility, the DOE has identified and characterized the contaminated areas and has undertaken to decontaminate some of them (see Figure 4) [3]. The decontamination is carried out by projection of water on the walls in order to dissolve the salt on the surface and trap the radionuclides in the salt crystals which reform on the ground (see Figure 5). A polyethylene textile (brattice cloth) is then placed on the ground, and covered with uncontaminated crushed salt. This allows, according to the DOE [13], to reduce the contamination of the walls by 95 %. A spray-on fixative is then applied on areas of higher activity [14]. The DOE has no plans to clean up Panel 6 and Room 7 of Panel 7, due to their excessive contamination; these rooms will be therefore closed without being decontaminated (see below) [3]. The exhaust shaft will not be decontaminated either because of the technical difficulties of the operations [12]. The DOE [15] specifies that, for future operations of the facility, which need to take into account the presence of both contaminated and uncontaminated areas, this implies permanently maintaining air filtration (since the air is exhausted by the contaminated exhaust shaft) and supplementing the ventilation (see below).

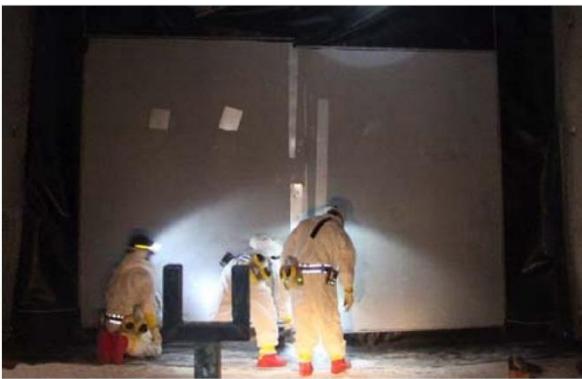
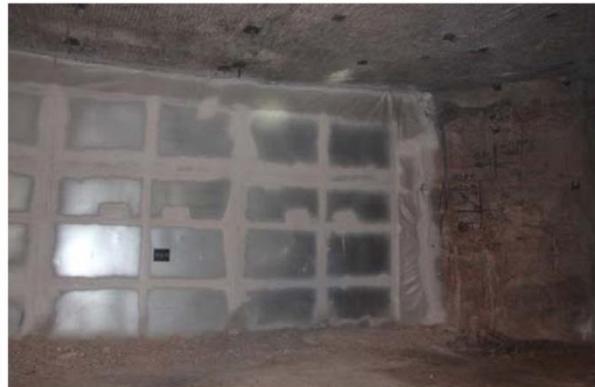
Figure 6: pictures of the bulkhead doors at the entry of Panel 6 (on the left) and Panel 7, Room 7 (on the right) [<http://www.wipp.energy.gov/pr/nr.htm>]

The DOE [16] presented a plan for initial closure of the parts of the disposal (Panel 6 and Room 7 of Panel 7) where the drums of the same waste stream as the offending drum have already been disposed of, in accordance with the request of the New Mexico Environment Department [17]. The operations provided for in the plan include the installation of a metal bulkhead coupled with an impermeable textile (brattice cloth) (see Figure 6) [16], located at the entrance of the Panel 6 and at the entrance of the Room 7 of Panel 7, isolating these spaces (see Figure 7); the DOE intends to emplace waste in the rest of Panel 7, which is currently contaminated [16]. These closure operations were completed in the beginning June 2015 [3]. According to a press article [18], the New Mexico Environment Department (NMED) indicated that a more durable closure system, such as an explosion-isolation wall, will be constructed.

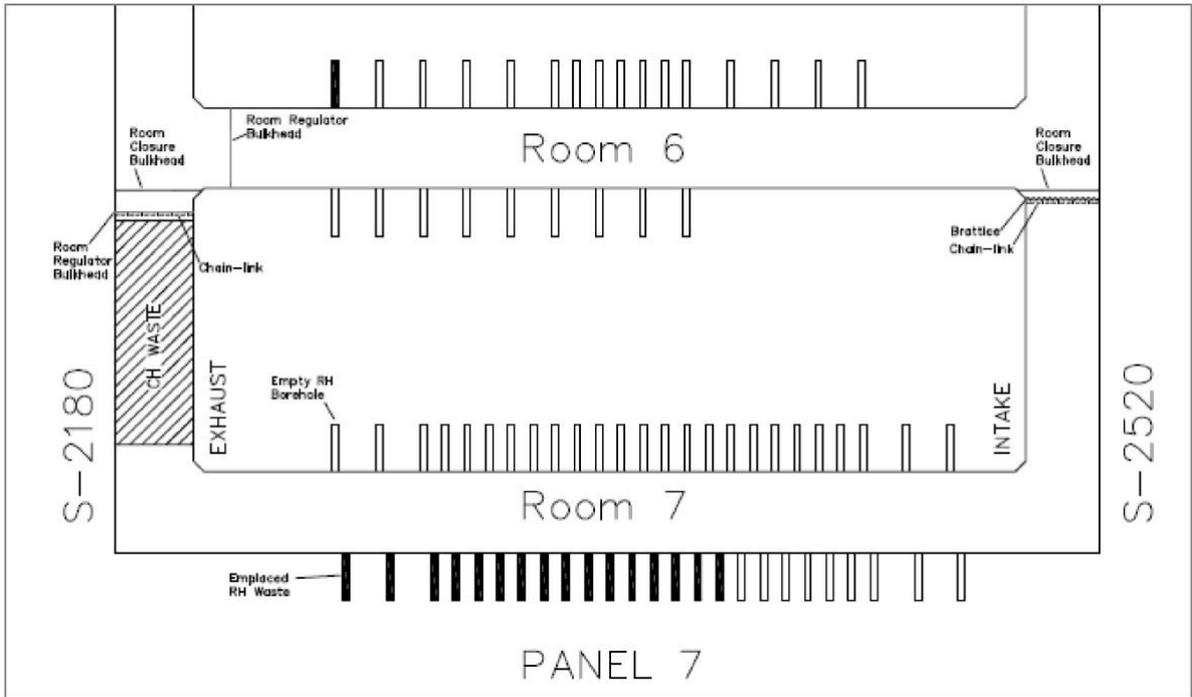
Figure 7 : bulkhead door locations as part of the closure process of the Room 7 of the Panel 7
http://www.wipp.energy.gov/library/Information_Repository_A/Responses_to_Administrative_Order/14-2614_WIPP_Nitrate_Salt_Bearing_Waste_Container_Isolation_Plan_2014%20Redacted.pdf
