Chapter 10

Operating experience feedback from French research reactors

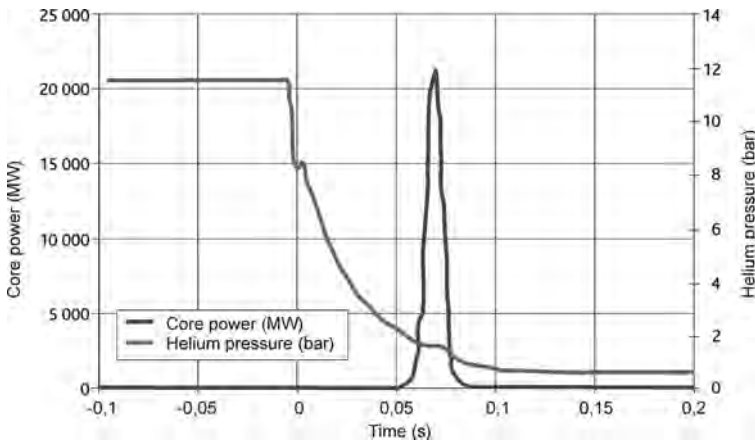
As indicated in chapter 5, the CABRI reactor was designed for power excursions (“pulses” – see figure 10.5) from maximum steady-state operating conditions of 25 MW. With a view to preventing the fuel melting, and ensuring the leaktightness of the cladding of rods in the driver core, the technical requirements for the facility stated that, during these power excursions, the maximum fuel temperature should not exceed 2,400°C²⁷⁷, all uncertainties combined, and the surfacic thermal power of the core rods²⁷⁸ should remain below 750 W/cm² (criteria to be respected in estimates via calculation, *prior* to experiments). In addition, these technical requirements authorized reactor operation above 25 MW up to 42.5 MW for a maximum cumulative duration of 23 minutes in order to perform slow power ramps; in these conditions, the maximum temperature of the fuel should not exceed 2,768°C, all uncertainties combined (requirements indicated in the safety report, justified by calculations).

Figure 10.5. Example of a power-time profile for a “pulse” of power in the CABRI reactor. © Georges Goué/IRSN.

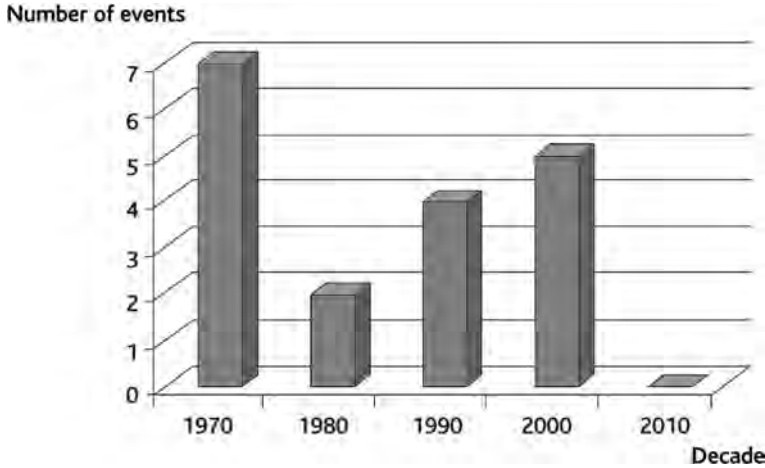
per decade). These occurred at six reactors, chiefly the SILOE, ISIS and OSIRIS reactors, as well as RHF. The change in the number of events over time is shown in [figure 10.6](#) below.

Figure 10.6. Change in the number of worker exposure events over the 1970s, 1980s, 1990s, 2000s and 2010s (2010-2014) in French research reactors. © Georges Goué/IRSN.

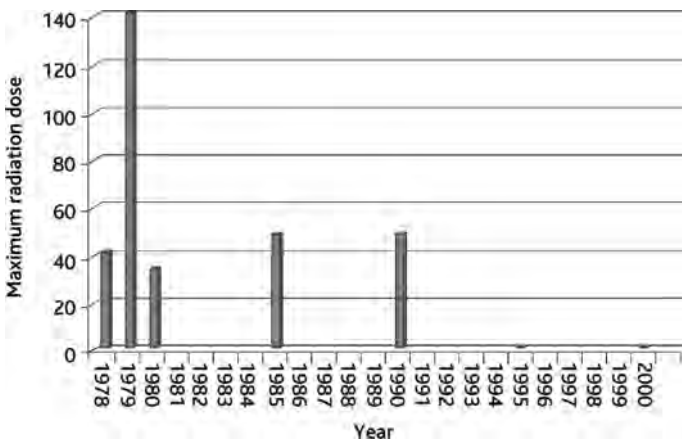
Over a period of 41 years (1973-2014), around 30 people were exposed to radiation, with maximum doses in the order of 40 mSv, with the exception of the event that occurred at the SILOE reactor on November 15, 1979: when a photographic film was being placed on an activated dysprosium plate previously irradiated in the axis of a beam, an operator received a dose estimated at 140 mSv (X-ray, β and γ radiation). Since 1990, there have been no cases in which workers have received significant doses of radiation ([figure 10.7](#)).

Figure 10.7. Change in the maximum radiation dose received by operators at French research reactors, in mSv (1978, 1979, 1980, 1985, 1990). © Georges Goué/IRSN.
